SUBJECT John Anglin, Clarence Anglin and
Frank Lee Morris Escape from Alcatraz

FILE NUMBER 76-26295

VOLUME NUMBER Enclosures 76, 137, 155 and 179

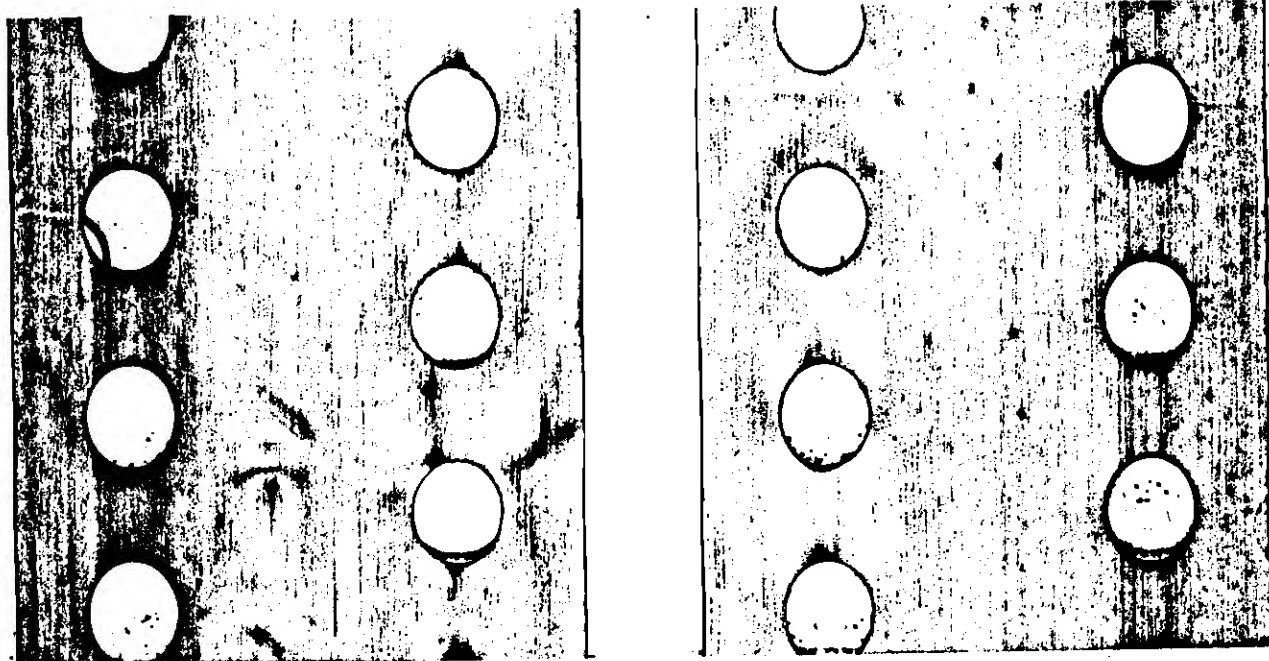
1-10 This is a photograph of an imprint of what appears to be the left foot. This print is headed in a northwesterly direction. The imprint appears to be that of the sole of a tennis shoe and is one of a number of fragmentary such prints visible on the roof indicating the direction of travel.

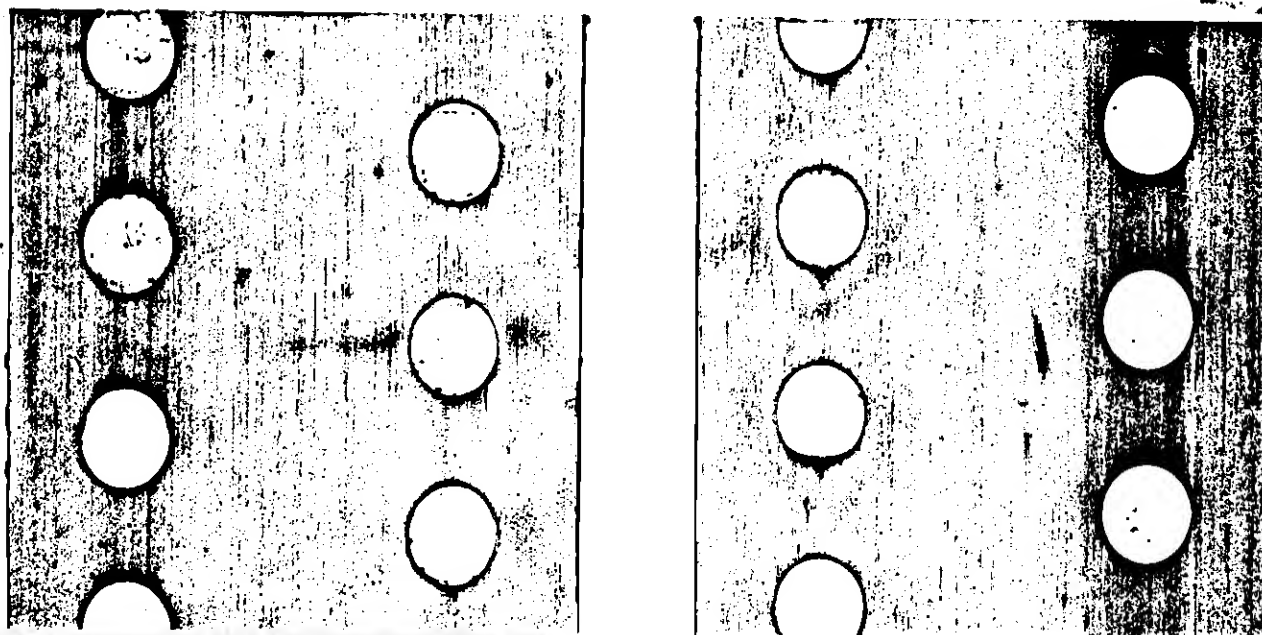
1-11 Photograph of two foot-print impressions, left one being the same as appearing in 1-10. Both prints headed in a northwesterly direction toward the water tower. While the impression of the foot print at the right appears to be distorted, it is a clear print and the angle of the photograph makes it appear in a distorted manner. The distance between the two prints was four feet one and one-eighth inches, indicating that someone apparently was running. These photographs were taken between the utility pipe and the skylight, which may be seen in photograph 1-7.

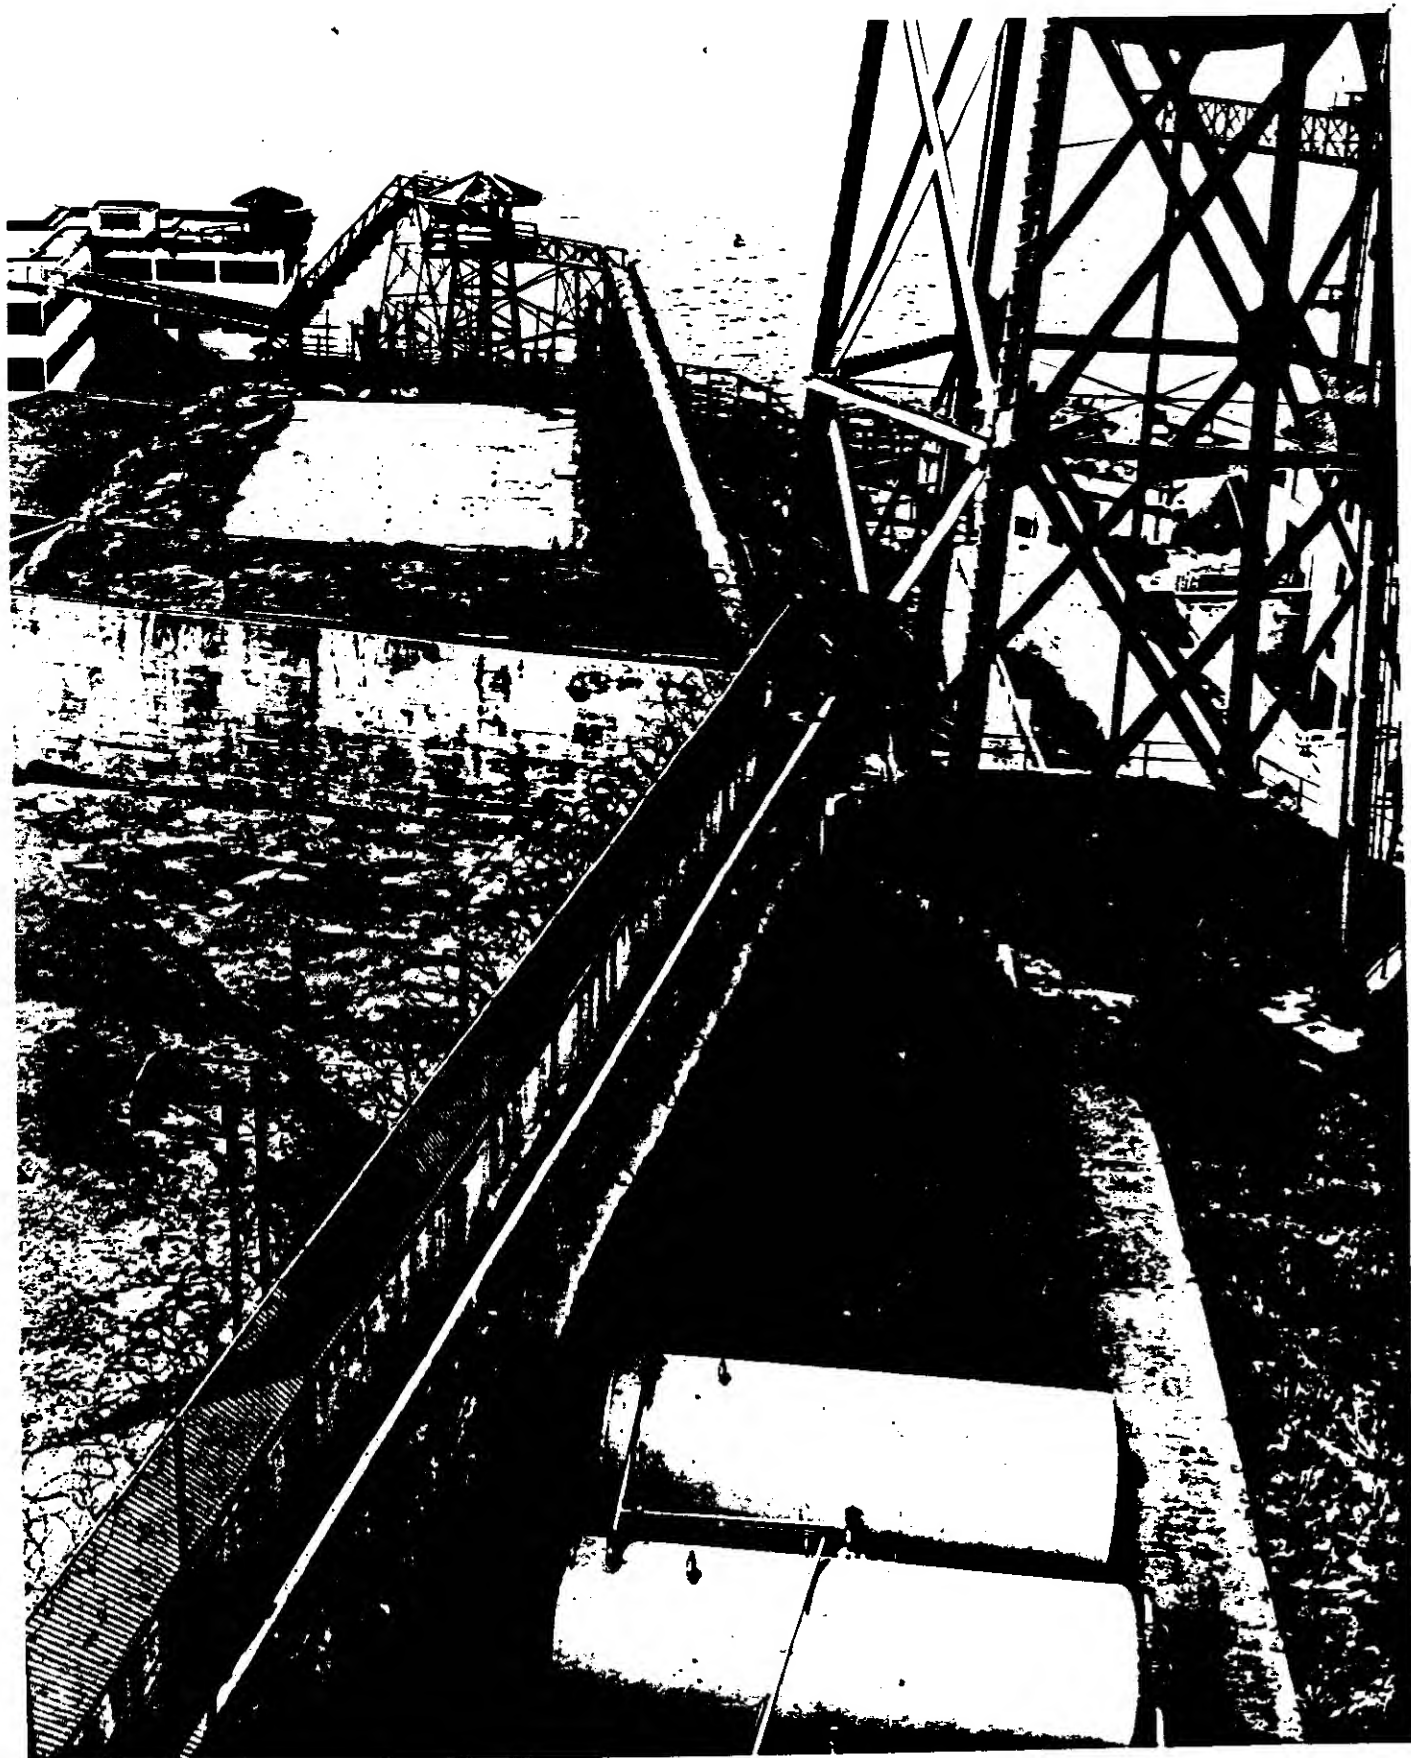
2-2 A general northern view taken from the top of the prison building. The area immediately to the left and center is the recreation area and at the far end may be seen guard tower number 4 and guard tower number 3 and guard tower number 2. None of these guard towers are manned during the night.

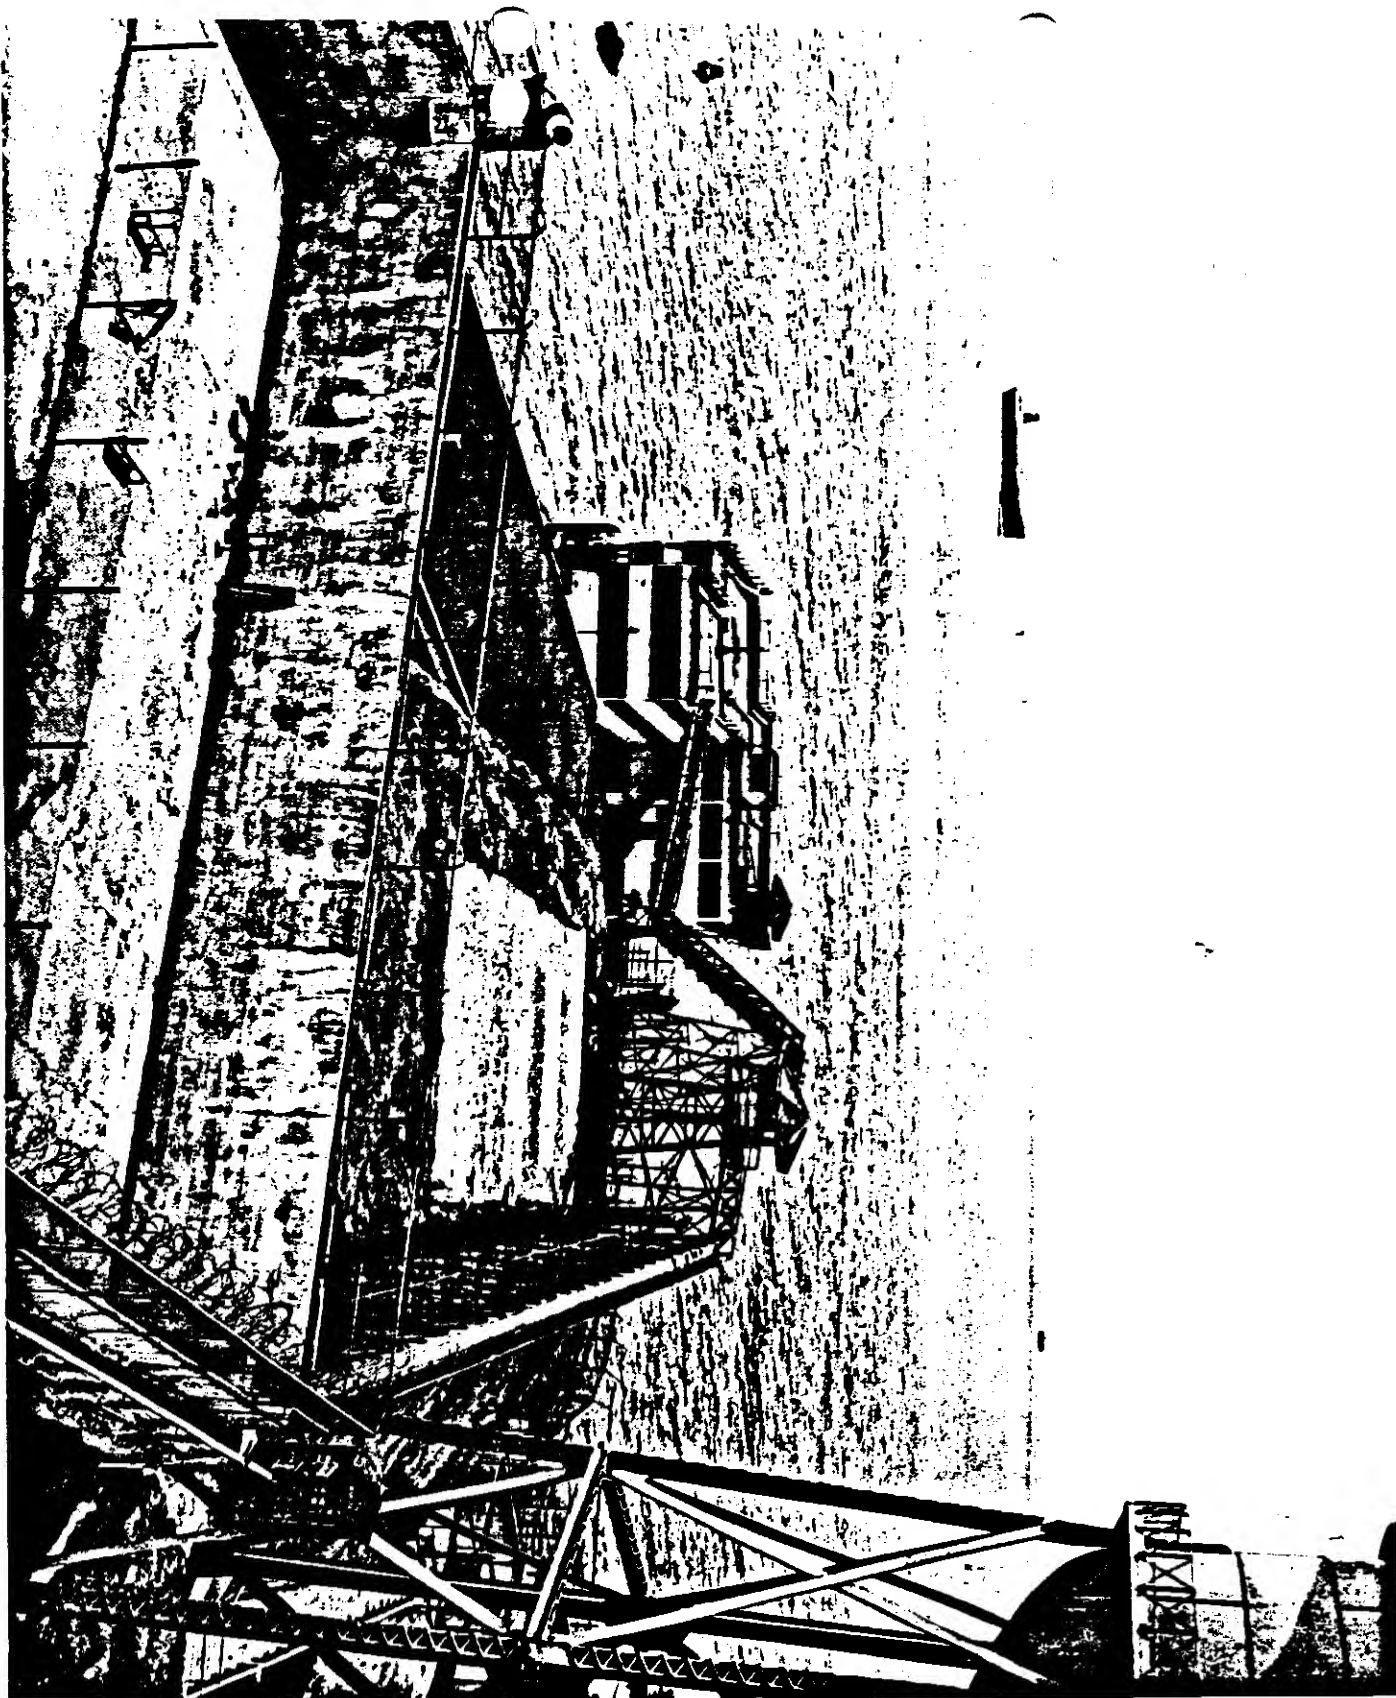
2-3 Same general view as 2-2 except that a larger portion of the recreation area is visible.

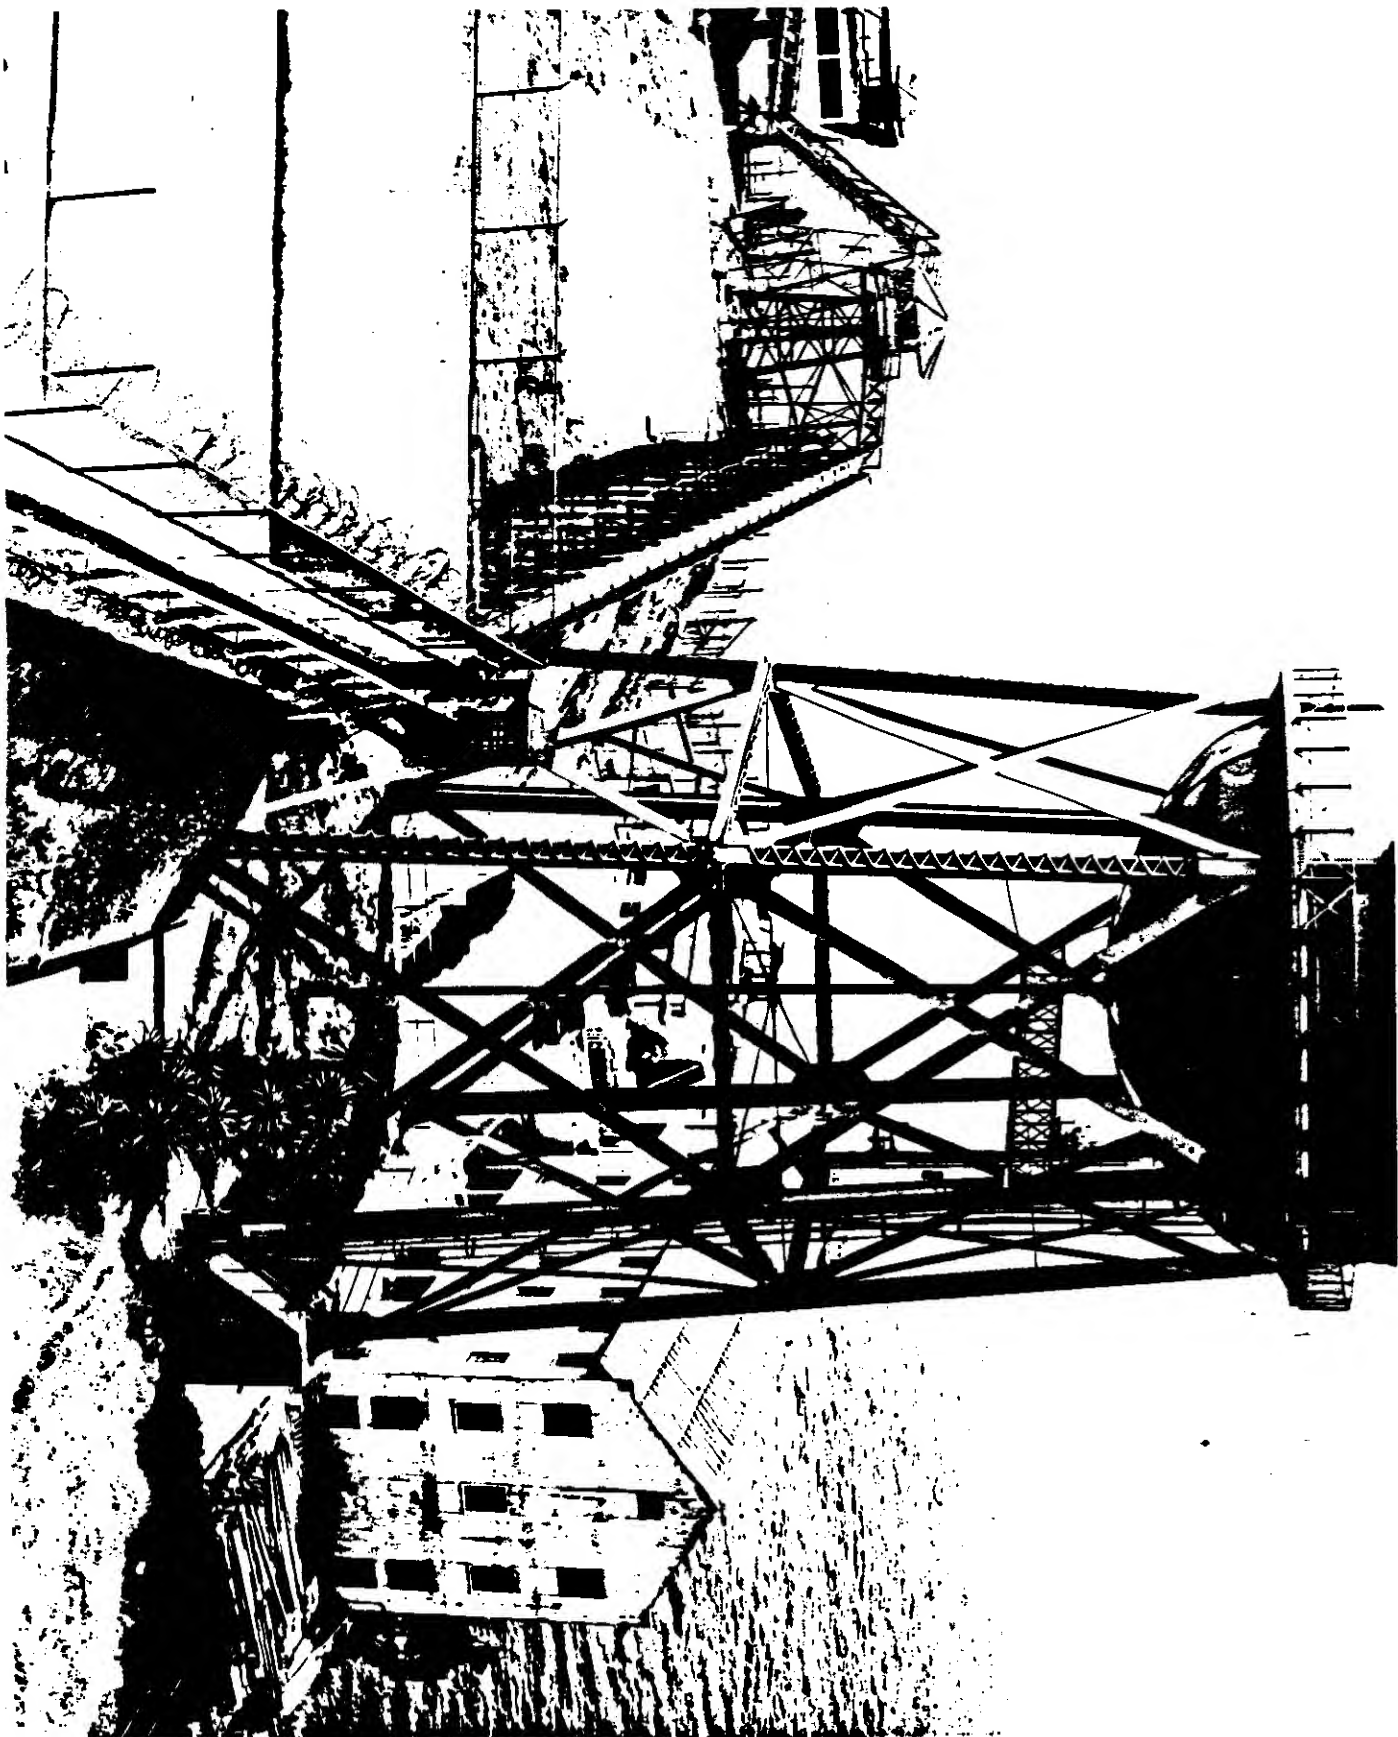
2-4 Same general view as previous photographs with the exception that the industrial building is shown in more detail.

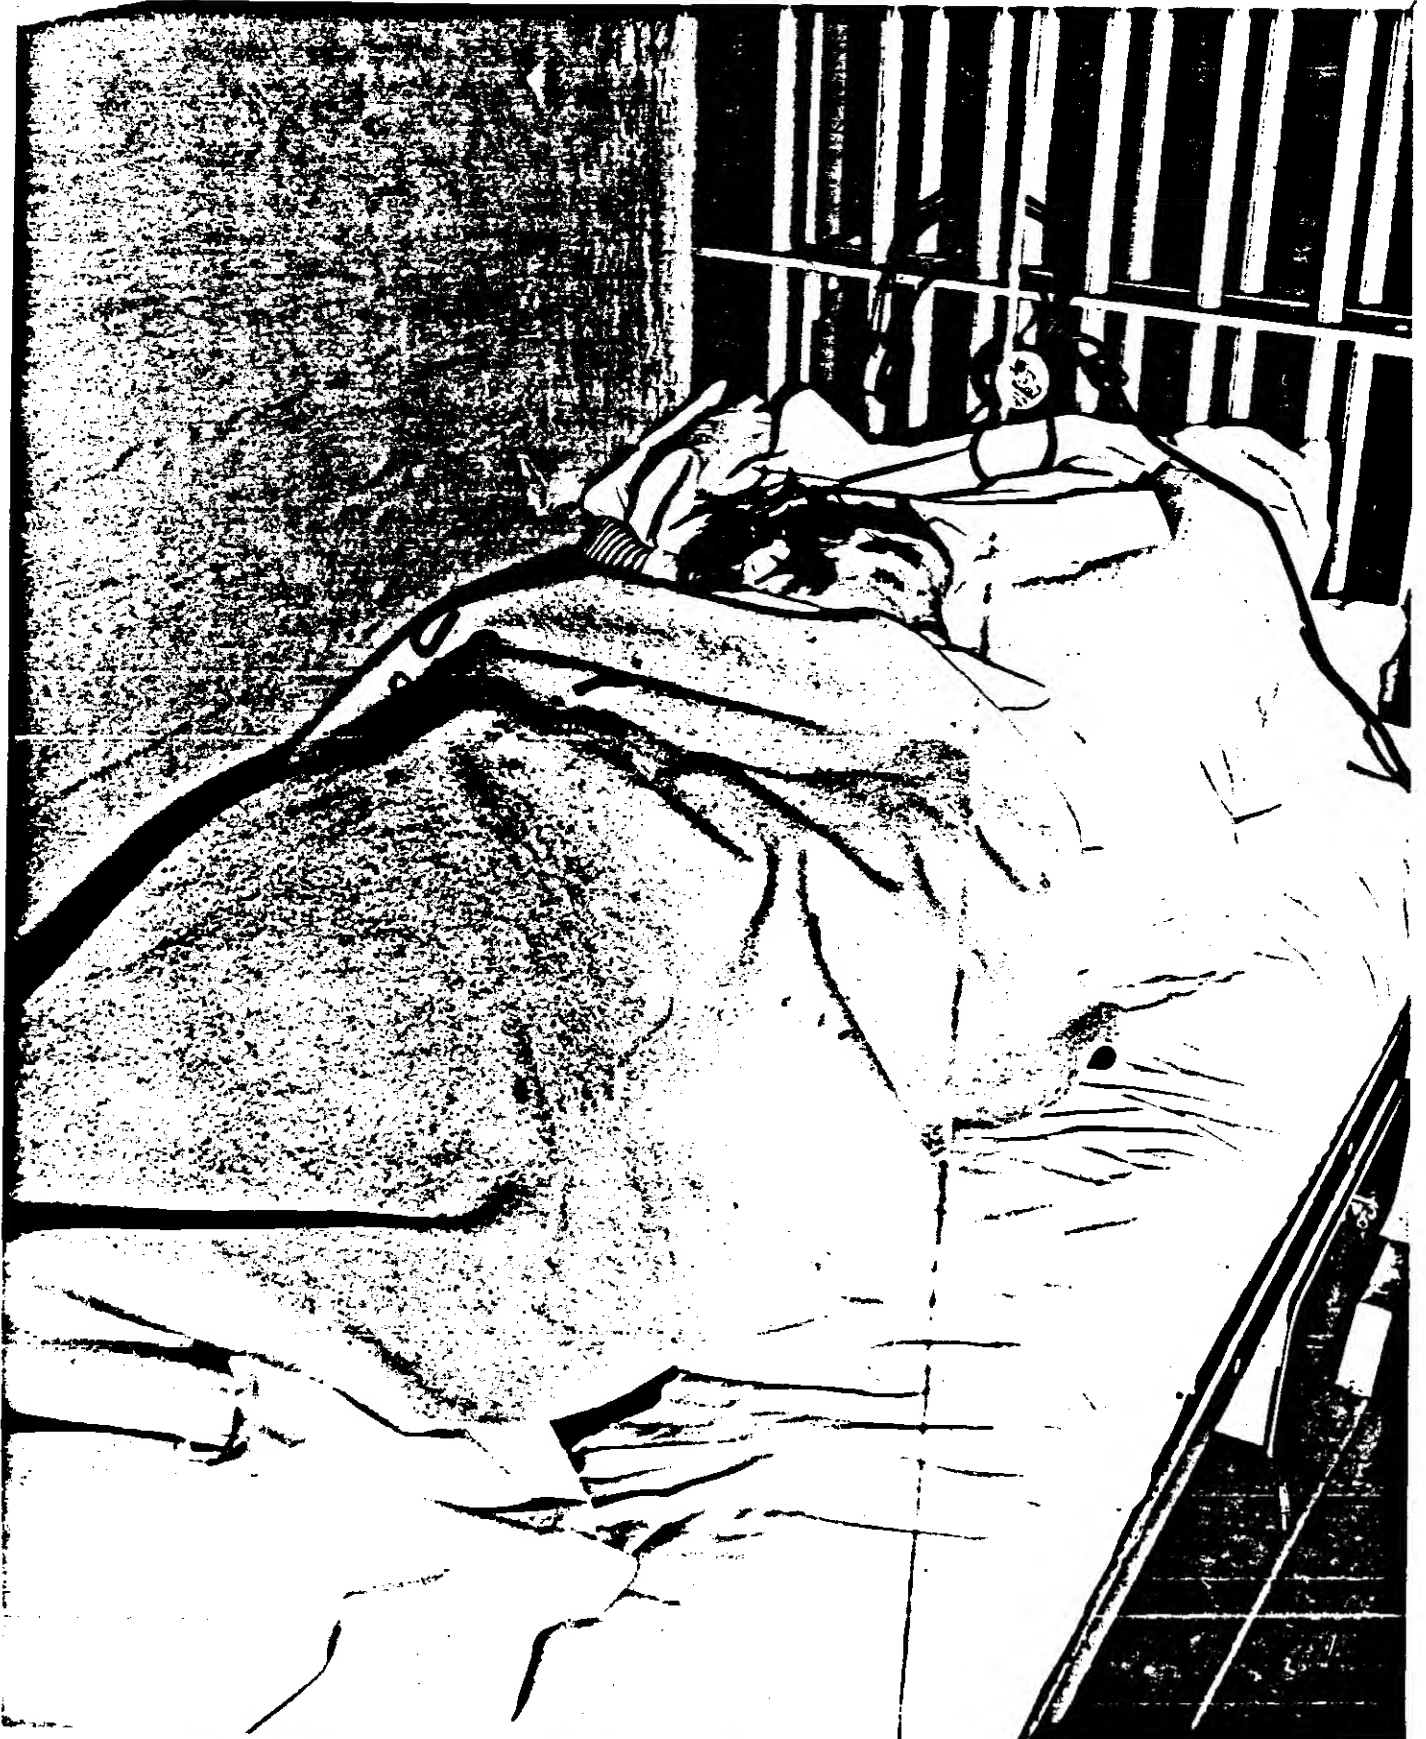
3-3 Photograph taken in Cell 152 B from foot of bed looking toward head of bed.

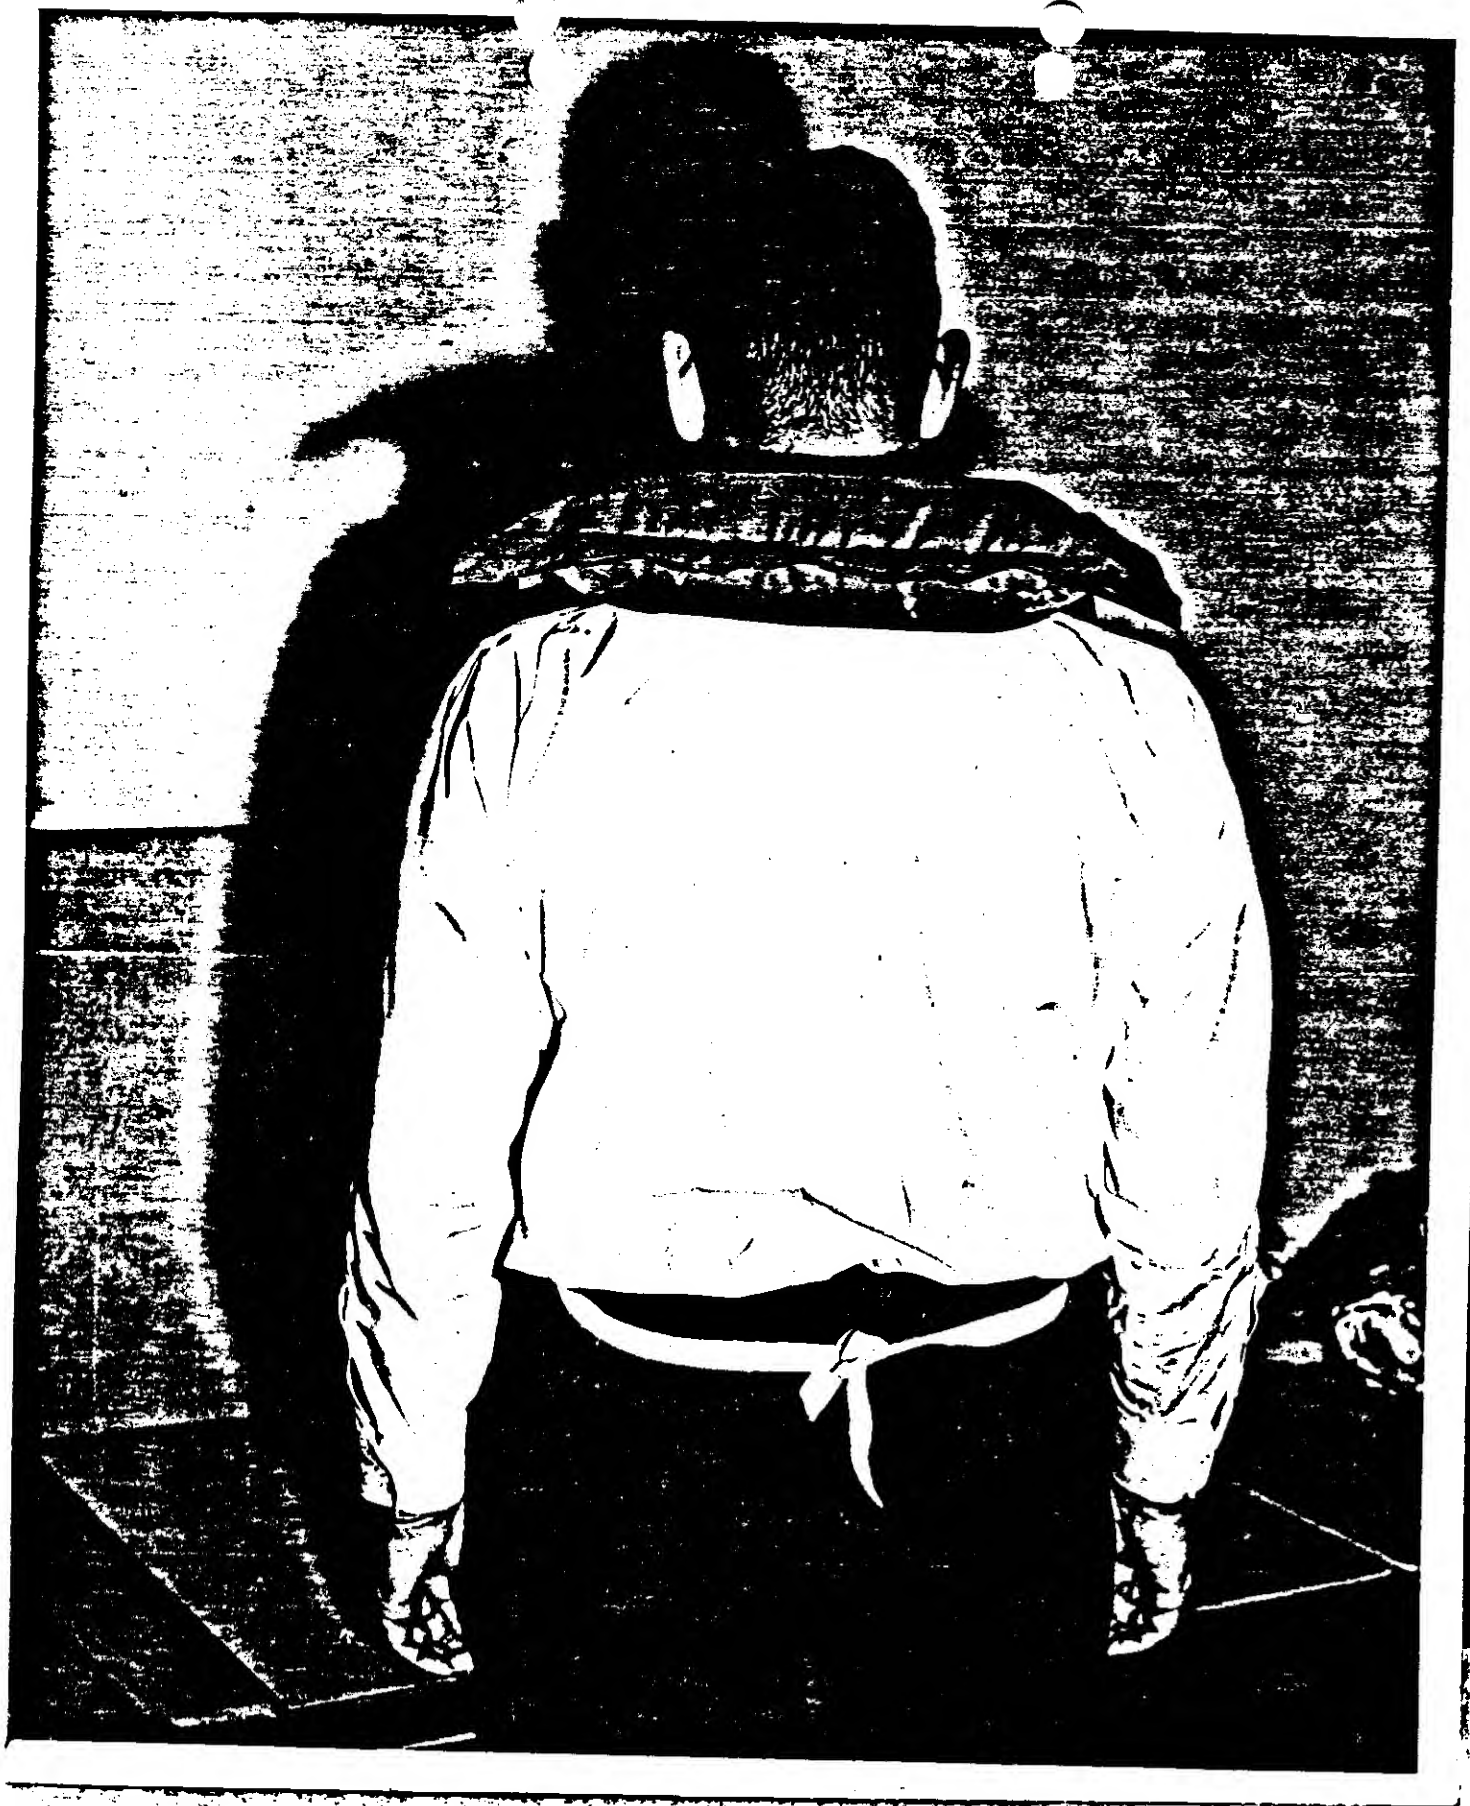
Rear view of yoke type vest being modeled by Special Agent.
(Photo by SA [REDACTED] 6/14/62)

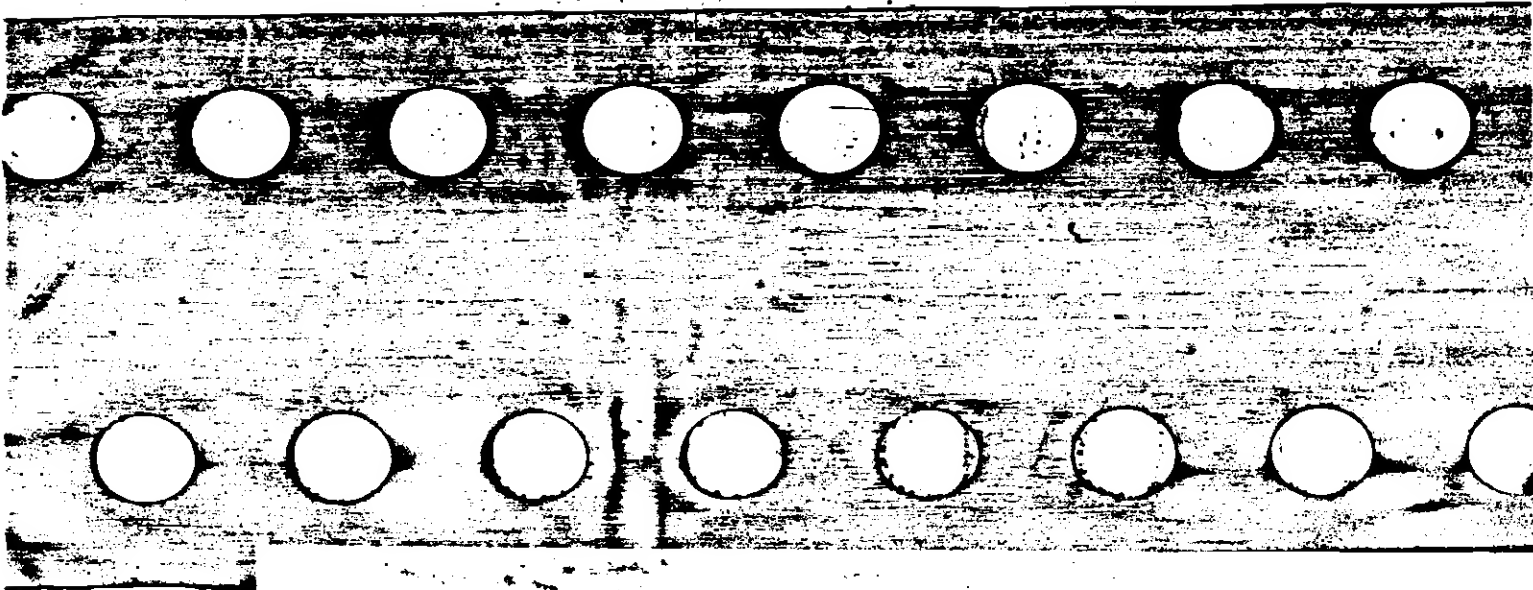
Rear view of concrete replica showing hard board. Note the wire hooks which were used to draw the replica into place from the inside of the cell.
